**Student Residence at 139-
149 North King Street,
Dublin 7**

**Structural Methodology Report
on the Retained Masonry
Façade and Existing
Structures**

CORA Consulting Engineers

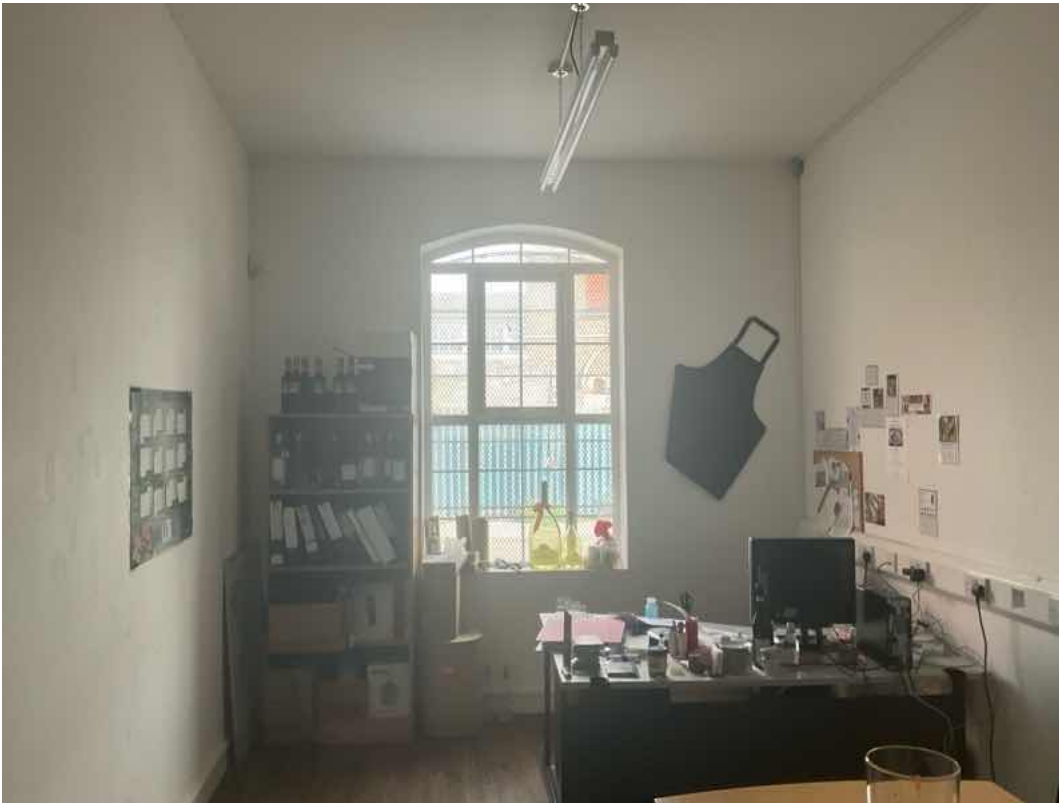
2 + 26/07/2024

Inside view

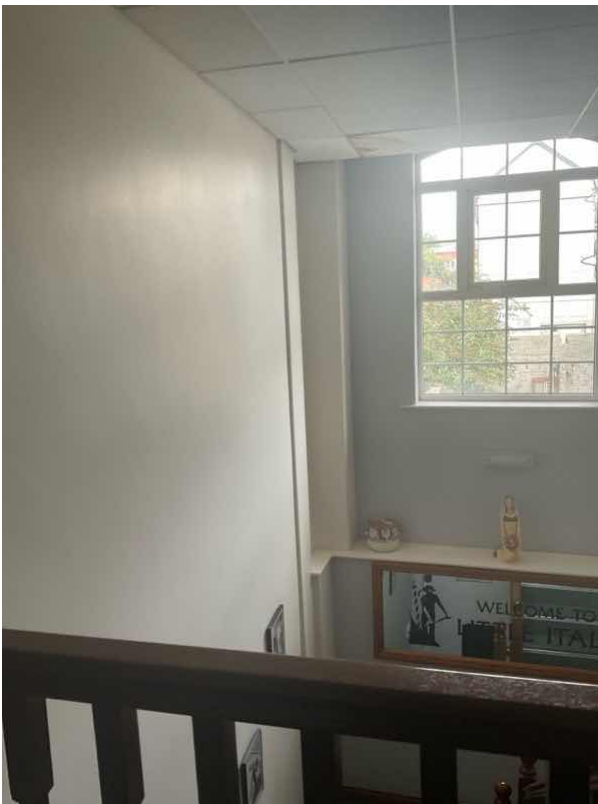
3 + 26/07/2024

Return wall

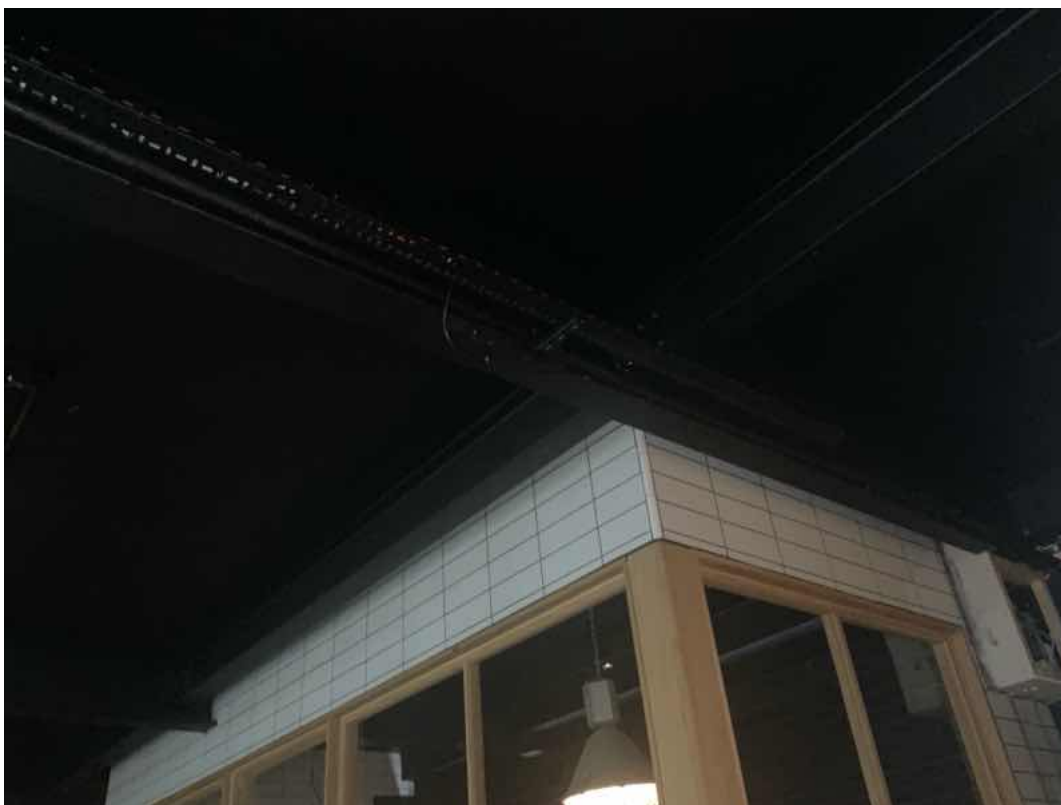
6 + 26/07/2024

Steel framed superstructure internally

The steel framed structures fronting onto North King St. include a number of historic steel sections (tapered flanges).

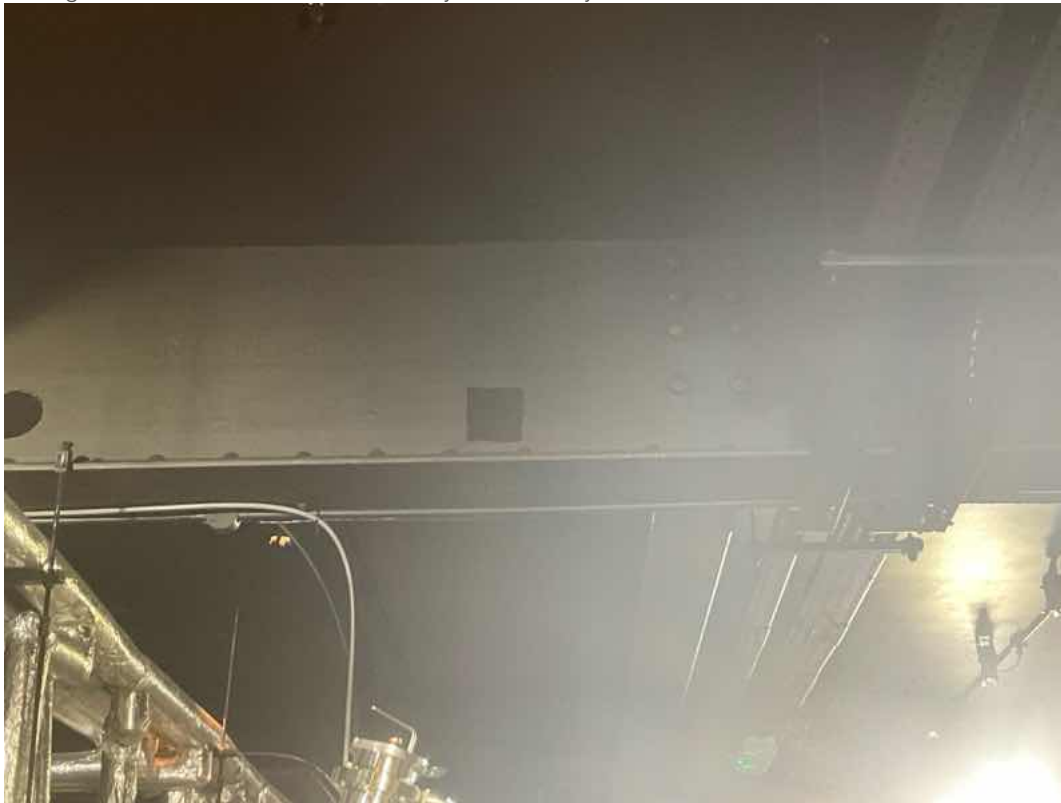
7 + 26/07/2024

Rivet girders and connection in steel early 20th century

There are a number of historical steel sections forming the industrial units. These sections carry a roof only in general and in some cases a mezzanine floor and roof.

However as the new development is seven floors the load capacity of these elements is not adequate to be incorporated within the new development. Furthermore the grid layout does not fit within the proposed layout and column positions would be located within the middle of bedrooms and result in a very inefficient design and a viable layout would not be possible.

Therefore the option to reuse these elements was ruled out, but the elements can be salvaged for use in non-structural features within common spaces internally and externally.

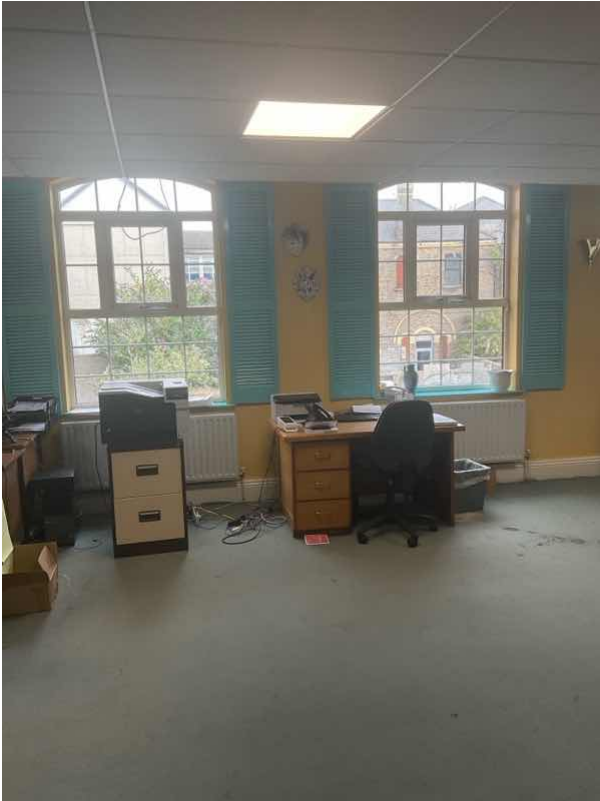
5 + 26/07/2024

View inside

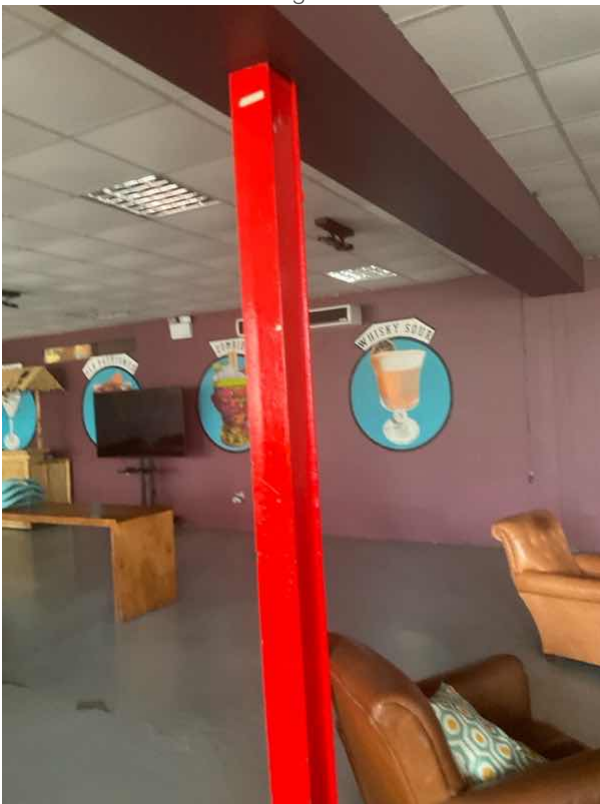
8 + 26/07/2024

Section sizes reduced rising from FF

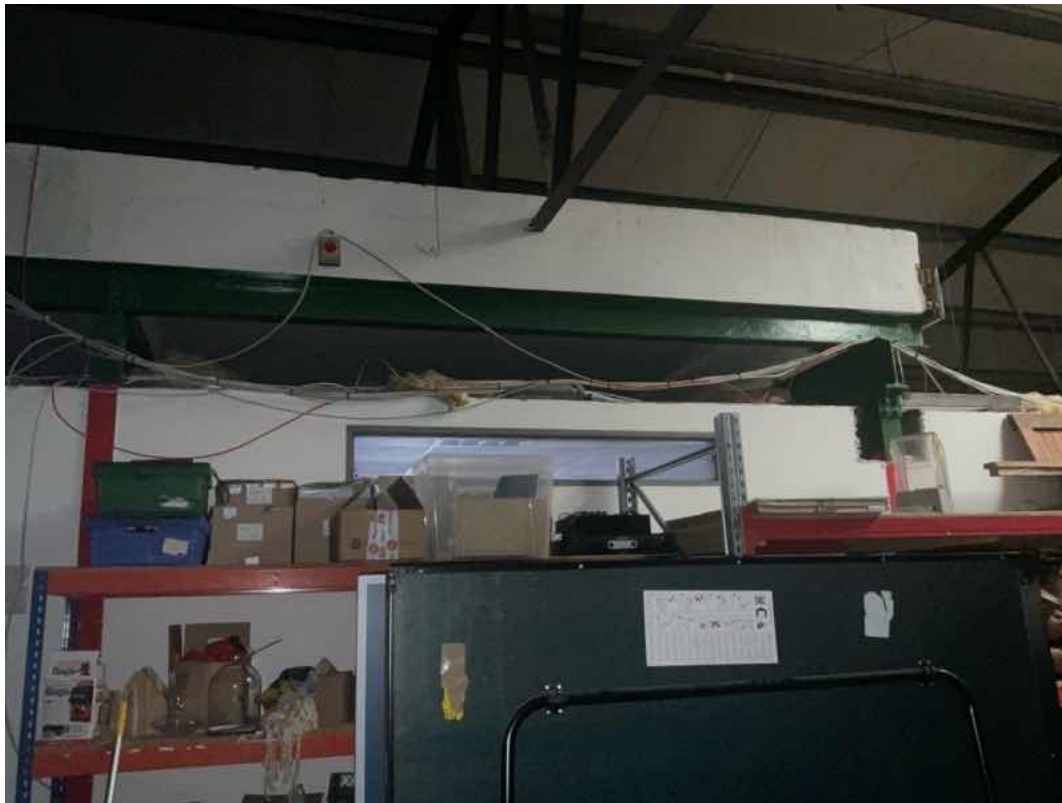
9 + 26/07/2024

False roof over bar area
Modern roof over

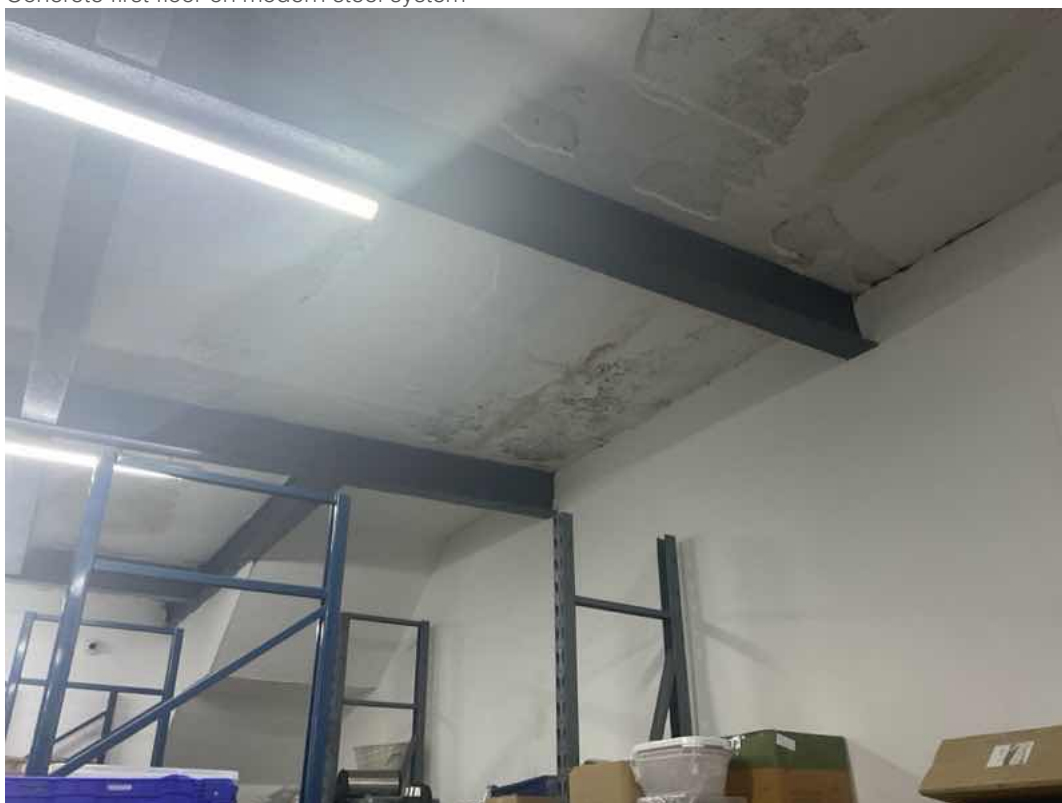
10 + 26/07/2024

Concrete first floor on modern steel system

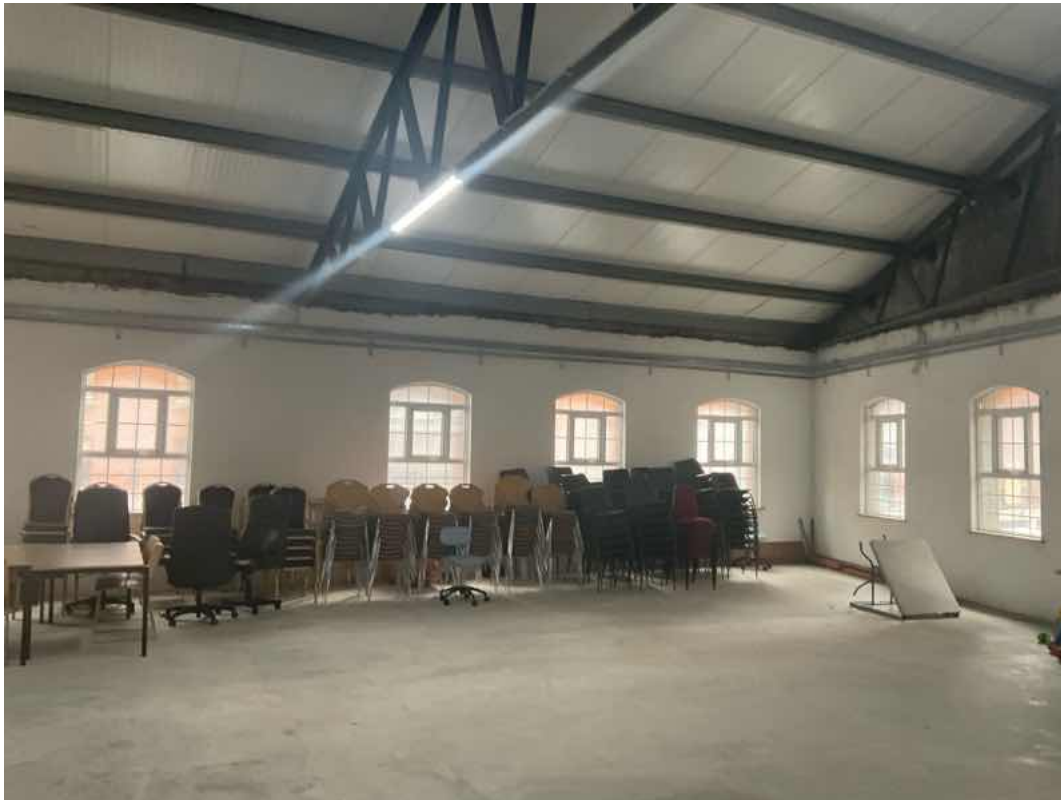
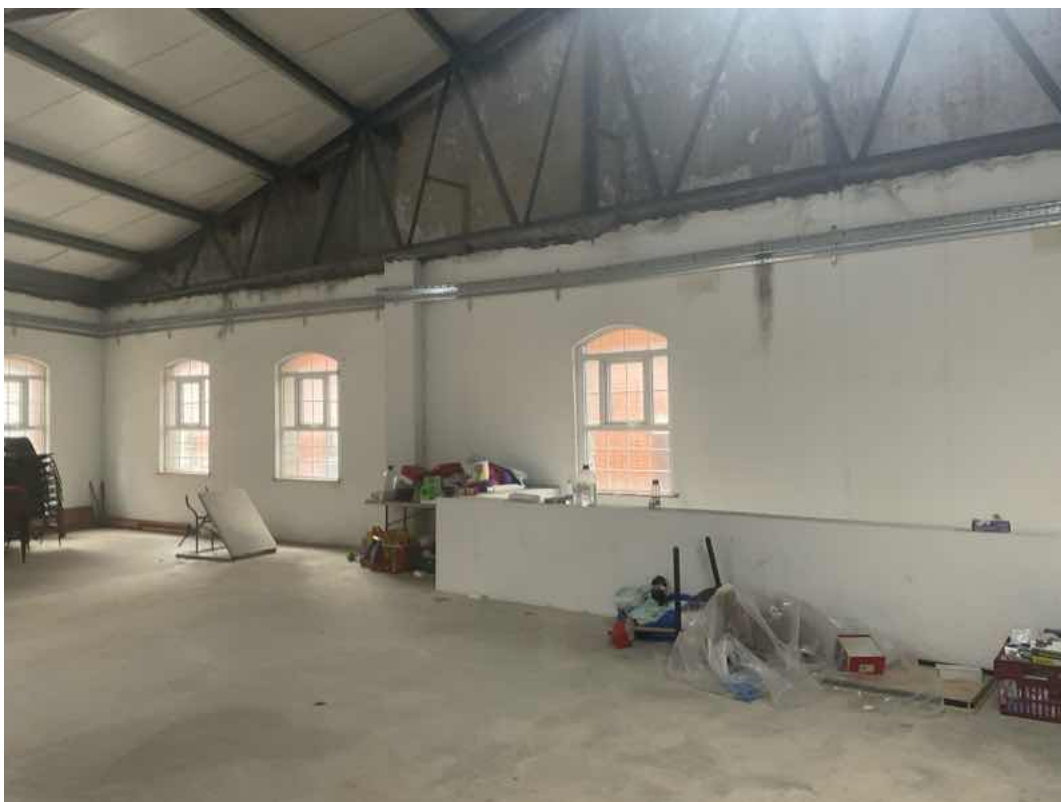
16 + 26/07/2024

Views of FF

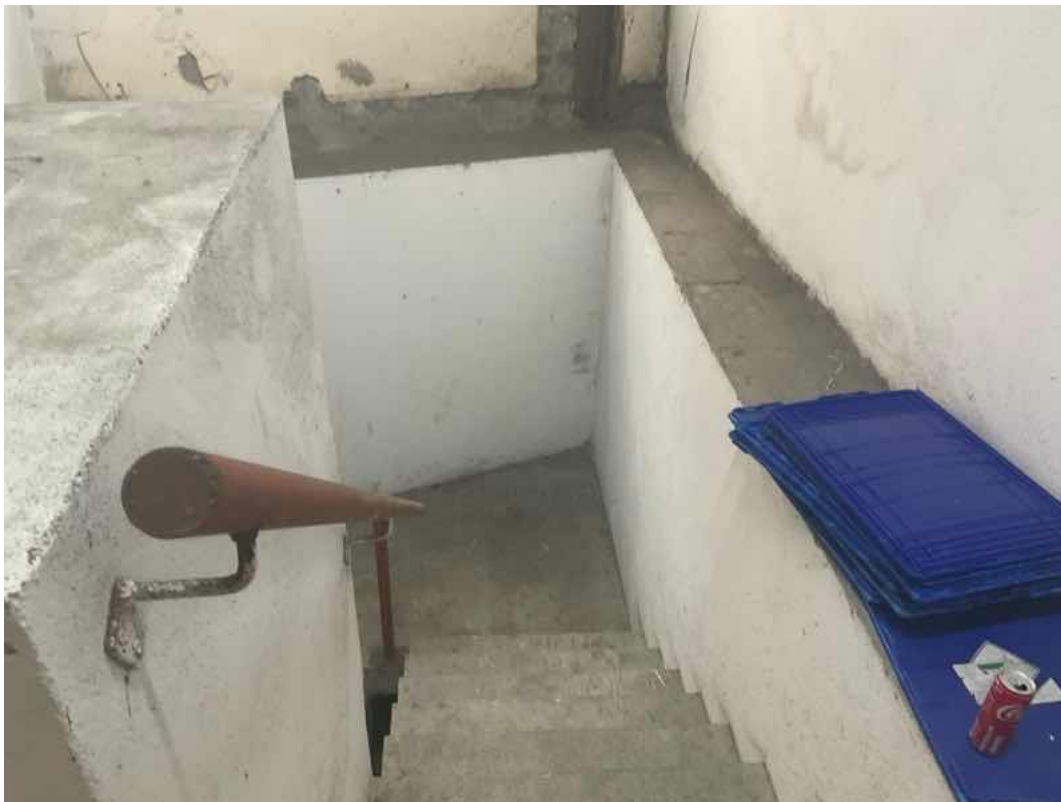
11 + 26/07/2024

Basement view

There is a small basement on the site which shall be retained and modified internally for uses as plantroom and other back of house uses.

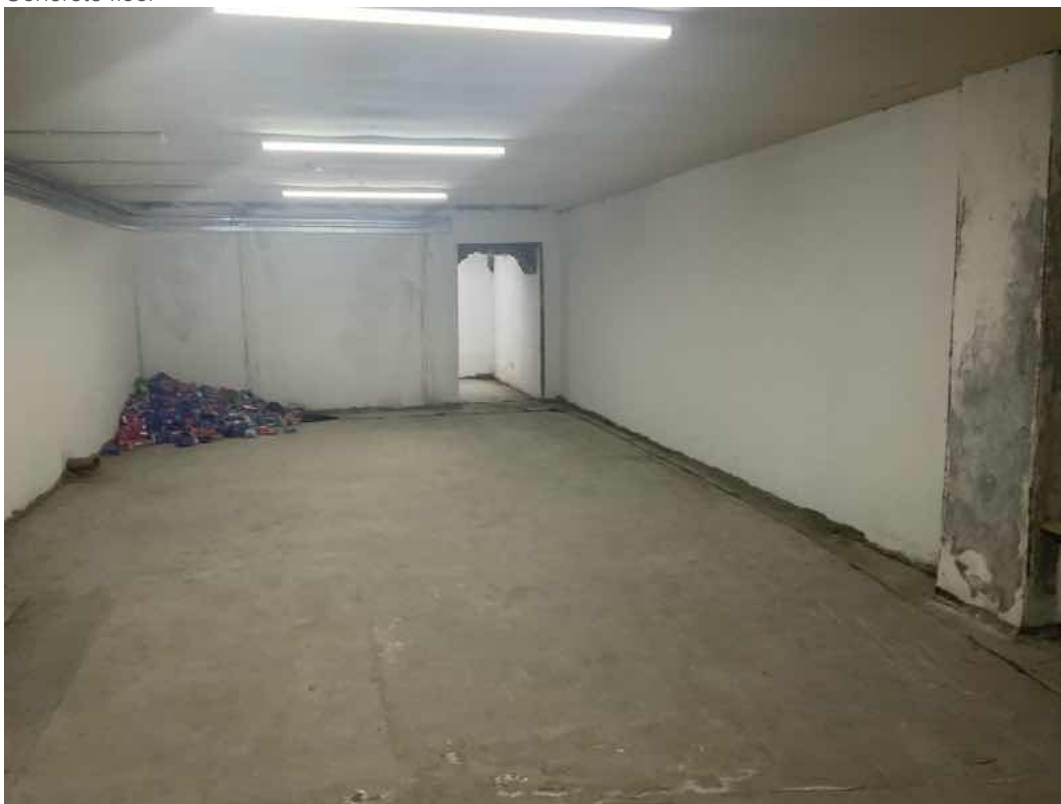
12 + 26/07/2024

Concrete floor

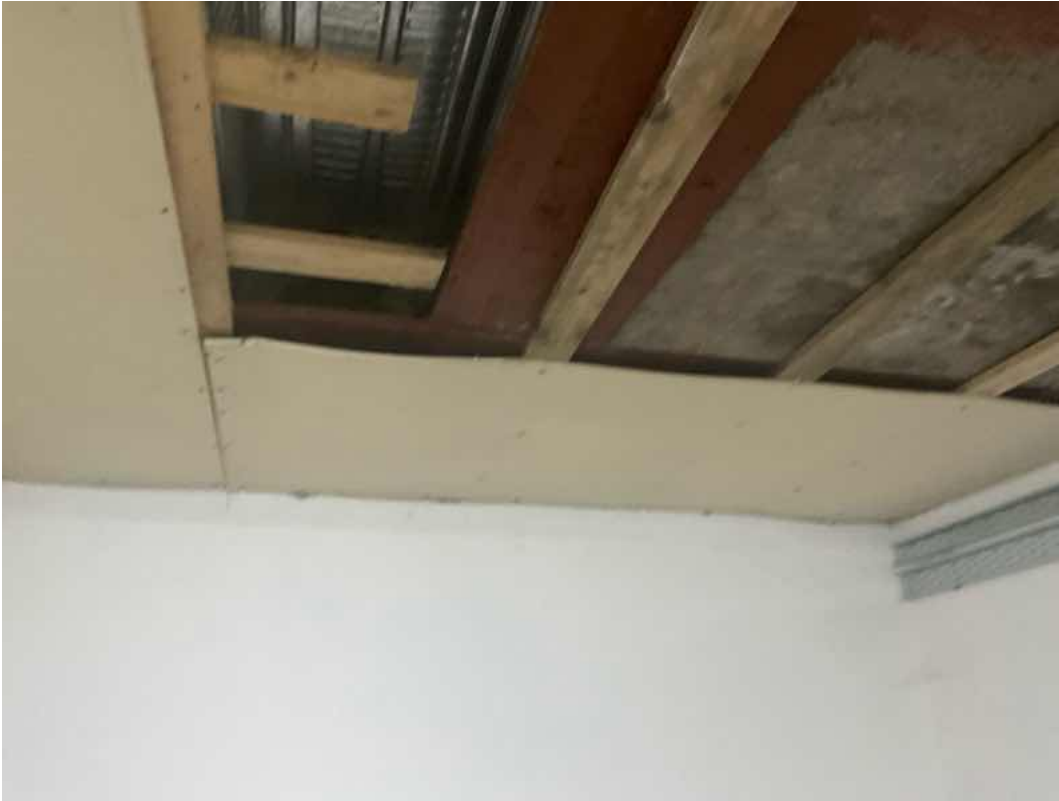
13 + 26/07/2024

View of GF

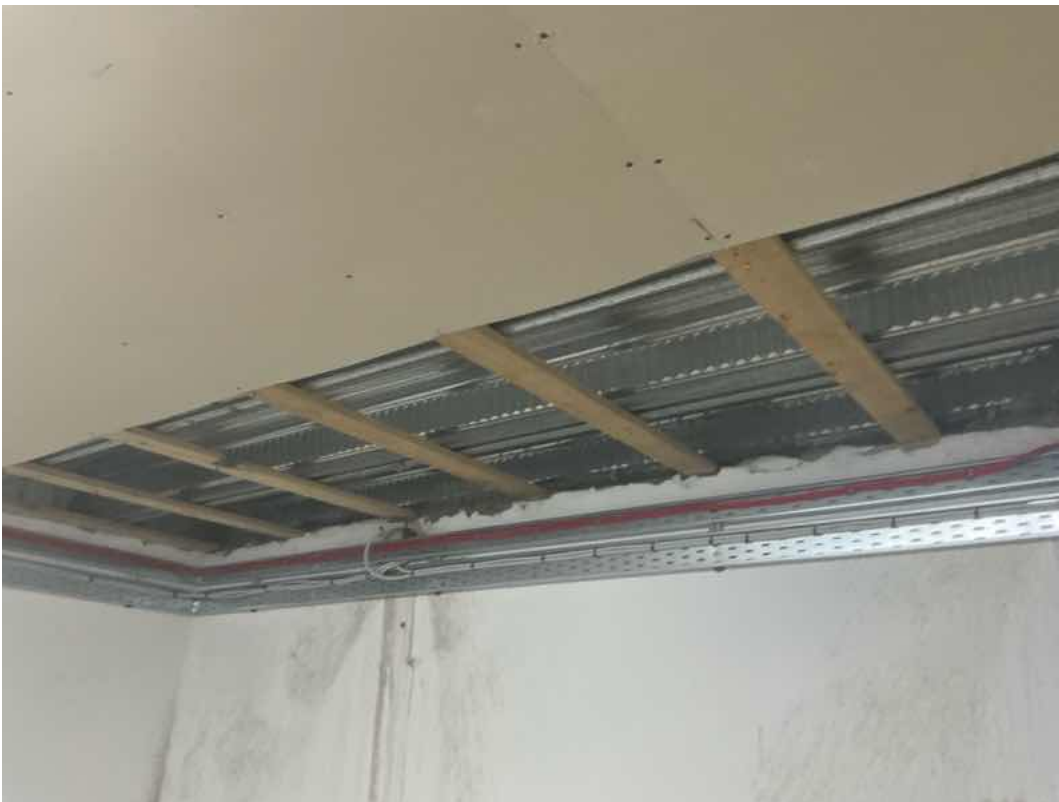
14 + 26/07/2024

GF metal deck

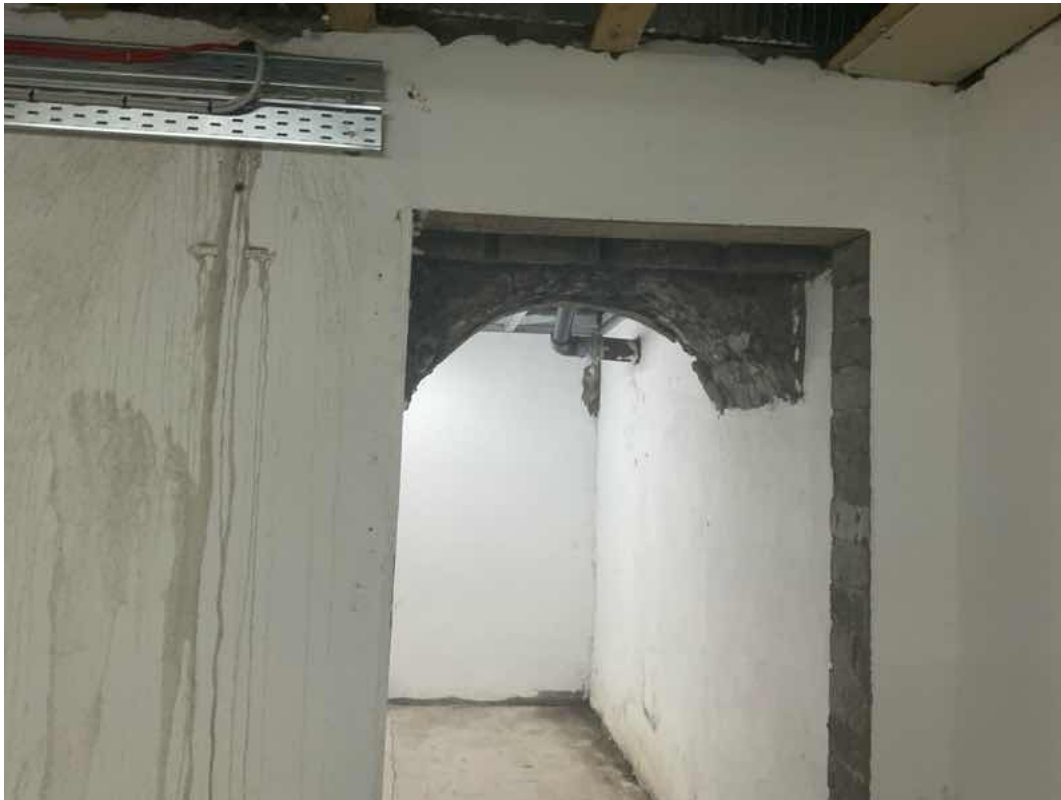
15 + 26/07/2024

Remnant of vault
